# **INDOOR AIR QUALITY POST-OCCUPANCY ASSESSMENT**

**Department of Industrial Accidents  
2 Avenue de Lafayette  
Boston**

Prepared by:  
Massachusetts Department of Public Health  
Bureau of Environmental Health  
Indoor Air Quality Program  
October 2019

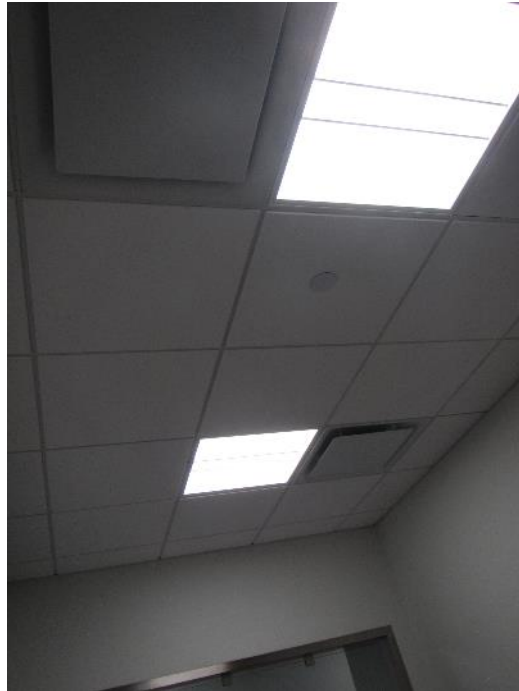
**Picture 1**

The HVAC system consists of air handling units (AHUs) located on the roof, which draw in outside air and heat/cool it. Air from the rooftop is ducted to multiple distribution units located in the ceiling. Tempered air is then delivered to spaces via ceiling-mounted supply vents (Picture 1). Other ceiling-mounted vents return air to the AHUs. The vent style for supply and returns is the same (Picture 1), so it is difficult to tell at a glance when rooms have both a supply and return vent.

**Supply and return vent in an office, note they are the same style**

16. Ensure all dusty surfaces are cleaned periodically, including supply and return vents, personal fans and flat surfaces.
17. Keep food preparation equipment clean, and clean out refrigerators, including the gaskets, regularly.

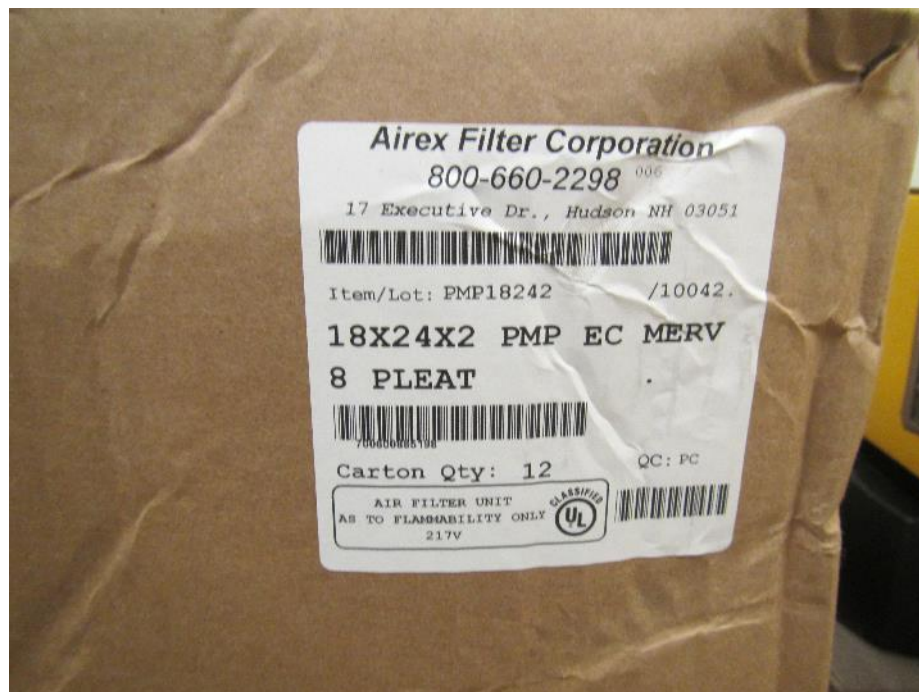
**Picture 2**

Ceiling-mounted AHUs have filters. During the pre-occupancy visit, a mesh type filter with low removal efficiency was found to be significantly covered in dust and debris. These filters were reportedly replaced during the move-in process. While the AHUs were not accessed during this visit, boxes of filters of the appropriate size for these interior AHUs were found, which have a Minimum Efficiency Reporting Value (MERV) rating of 8 (Picture 2). This rating is recommended to remove particles such as pollen and mold spores. Note that the AHUs on the

**Box full of new filters, pleated type with MERV rating of 8**

4. Change filters for HVAC equipment 2-4 times a year. Use pleated filters of MERV 8 (or higher), which are adequate in filtering out pollen and mold spores (ASHRAE, 2012).

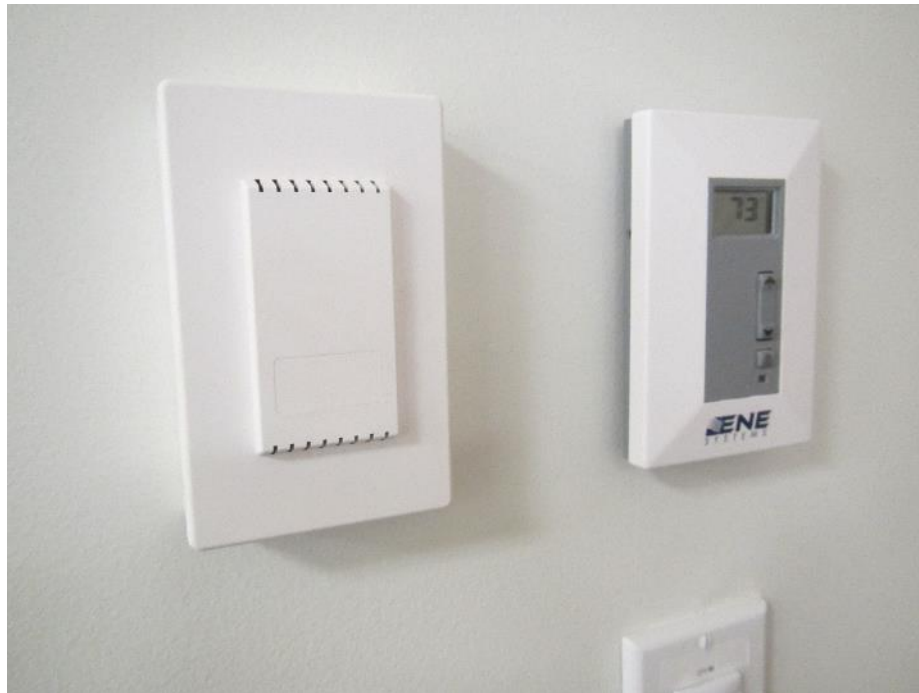
**Picture 3**

In some rooms, such as the conference rooms and the IT training room, there were unlabeled units on the wall next to thermostats (Picture 3). It is likely these are carbon dioxide sensors, designed to activate additional fresh air or exhaust when carbon dioxide levels rise in these rooms due to high occupancy. If these are sensors, they need to be calibrated or maintained periodically to ensure proper function.

**Unlabeled unit next to a thermostat which is likely a carbon dioxide sensor**

2. To address elevated carbon dioxide in heavily occupied areas, adjust HVAC system settings or open louvers to bring in more fresh air.
3. Recalibrate or replace carbon dioxide sensors and other sensors in accordance with manufacturer's instructions.

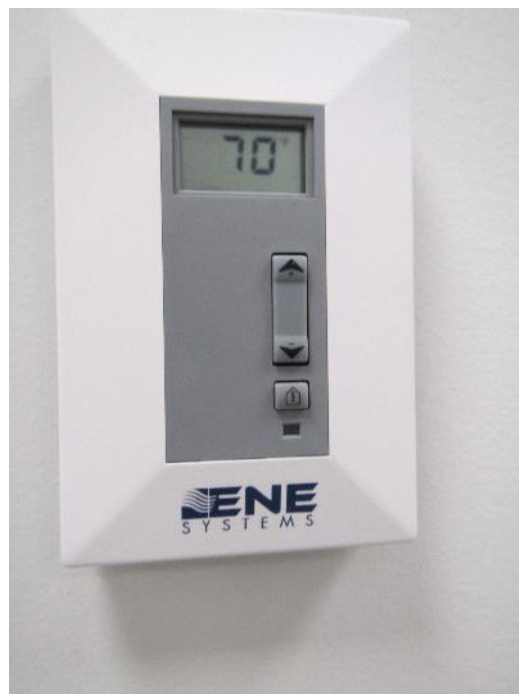
**Picture 4**

Note that thermostats are designed to allow occupants to change the set temperature in a small range of degrees (Picture 4). While all temperatures measured were within the BEH/IAQ recommended range, in some areas occupants reported that temperatures were frequently too warm or too cold. In some cases, the applicable thermostat was located in an unoccupied office or other area that is not representative of occupancy. Occupants should work with building management to address temperature control issues.

**Thermostat showing adjustment toggle which can change temperature setpoint by a few degrees**

7. Occupants should work with facility staff to address temperature issues.
8. Balance the HVAC system every 5 years in accordance with Sheet Metal and Air Conditioning Contractors' National Association (SMACNA) recommendations (SMACNA, 1994).

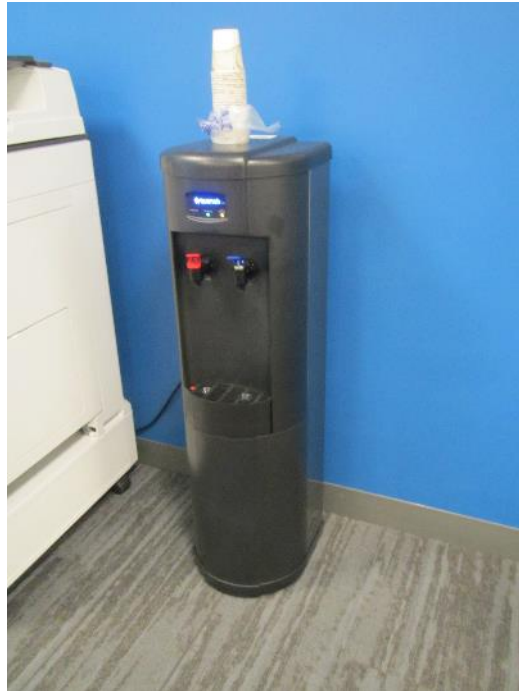
**Picture 5**

No water-damaged materials, water stains or musty odors were observed during the visit. Water dispensers and refrigerators were found in carpeted areas (Picture 5; Table 1). These

appliances can spill or leak and moisten carpeting. These should be placed in areas with non-porous flooring where possible or on a waterproof mat to protect carpeting.

**Water cooler on carpet**

9. Consider placing refrigerators and water dispensers in areas without carpeting, or use a waterproof mat to protect carpeting.
10. Keep plants and flowers in good condition, avoid overwatering, and remove from the airstream of heating and ventilation equipment.

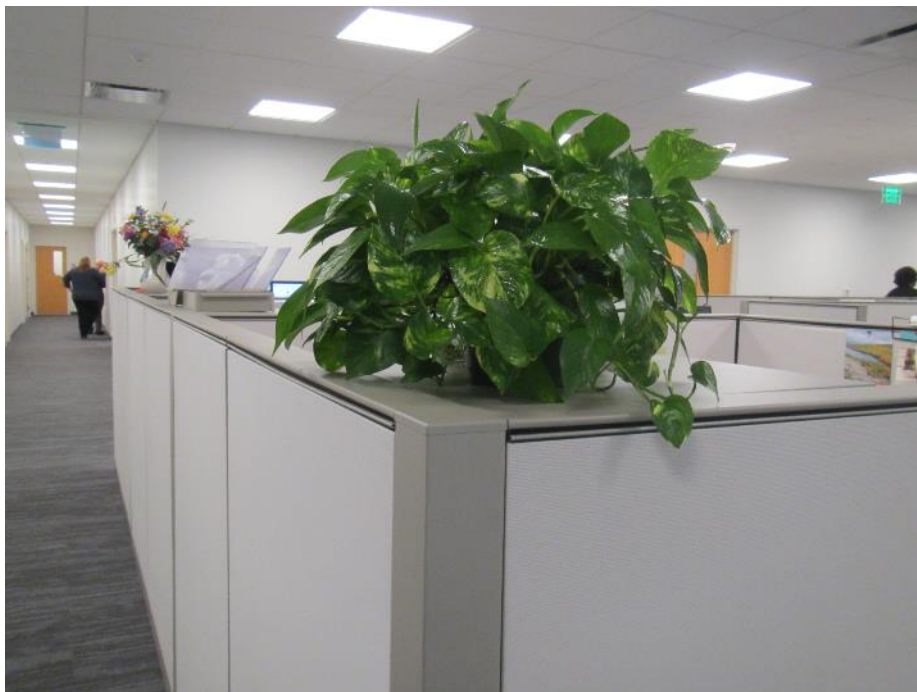
**Picture 6**

Plants were noted in some areas (Pictures 6 and 7; Table 1). Plants should be properly maintained and equipped with drip pans and should be located away from airflow to prevent the aerosolization of dirt, pollen, and mold. Plants should not be placed on porous surfaces. An aquarium was noted in one area. Aquariums also need to be kept clean to prevent odors.

**Office plant**

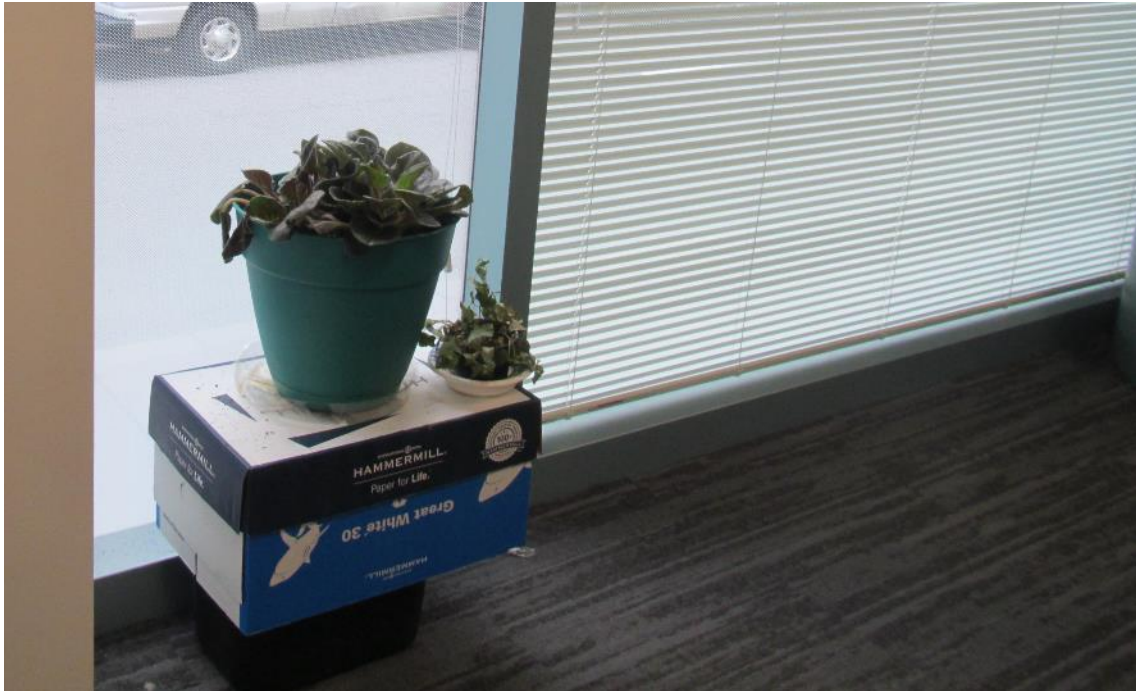
**Picture 7**

**Plant on a cardboard box**

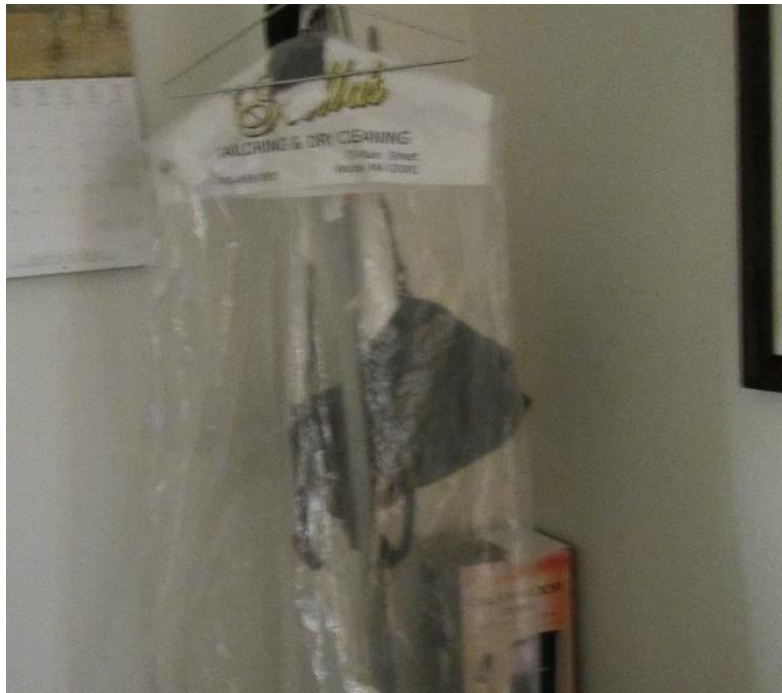
**Picture 9**

BEH/IAQ examined other areas for products containing VOCs. BEH/IAQ staff noted hand sanitizers, air fresheners, fragrance products, cleaners, and dry erase materials in the office space (Picture 8; Table 1). All of these products have the potential to be irritants to the eyes, nose, throat, and respiratory system of sensitive individuals. Several offices had bags of dry-cleaned judges' robes (Picture 9). Dry cleaning chemicals (e.g. tetrachloroethylene) can linger on dry cleaned clothes. Dry cleaned clothing should be stored in a well-ventilated area where possible.

**Bag from dry-cleaned robes**

13. Keep dry-cleaned clothing in well-ventilated areas where possible.
14. Store printed materials in closed boxes when not in use.
15. For buildings in New England, periods of low relative humidity during the winter are often unavoidable. Therefore, scrupulous cleaning practices should be adopted to minimize common indoor air contaminants whose irritant effects can be enhanced when the relative humidity is low. To control for dusts, a high efficiency particulate arrestance (HEPA) filter equipped vacuum cleaner in conjunction with wet wiping of all surfaces is recommended. Avoid the use of feather dusters. Drinking water during the day can help ease some symptoms associated with a dry environment (throat and sinus irritations).
